PAPAYA

Dental X-ray Imaging system

Panoramic Imaging
& Tomography Imaging

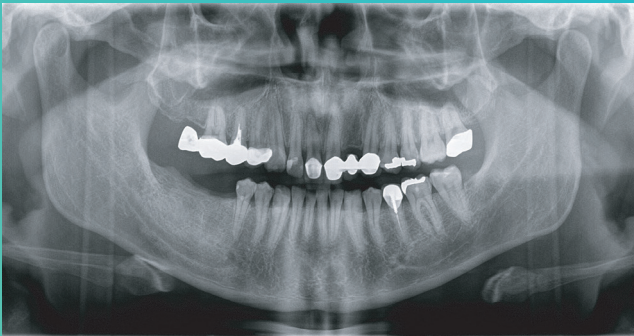
Standard panoramic

Standard panoramic, orthogonal panoramic, bitewing panoramic, child panoramic, TMJ lateral double, horizontal & vertical X-ray segmentation, TMJ PA double, TMJ LAT-PA, TMJ LAT-PA double, sinus lateral and sinus PA are supported.

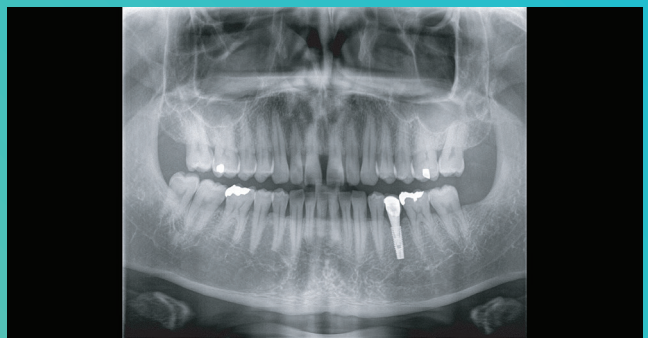
X-ray segment

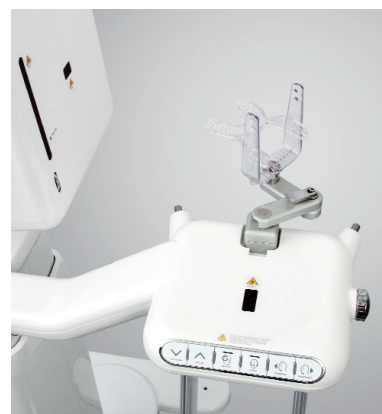
PAPAYA CUST is in a 3D imaging function that provides cross-sectional information for implant preparation.

- High image quality due to statistical reconstruction technique.
- 3D image has 256 cross-sectional slices having 0.195mm thickness and has FOV 50x50x103mm.
